**SITE REPORT #4 6.28.19**

**To:** Ray Dunetz  
Ray Dunetz Landscape Architecture  
**From:** Lisa Harrington  
**Date:** 6.28.19  
**Project:** Bas Relief Park, Provincetown, MA  
**Inspection Date:** 6.28.19  
**Weather:** Partly Cloudy, 72  
**Present:** Greg Myette, Myette Masonry & Design Inc. (MM)  
Lisa Harrington, BCA, Inc.

BCA was onsite today to review Myette Masonry's repointing mortar mock-ups, lead "T" joint cover mock-up, crack repair and dutchman installation, as well as conduct additional rust stain removal testing.

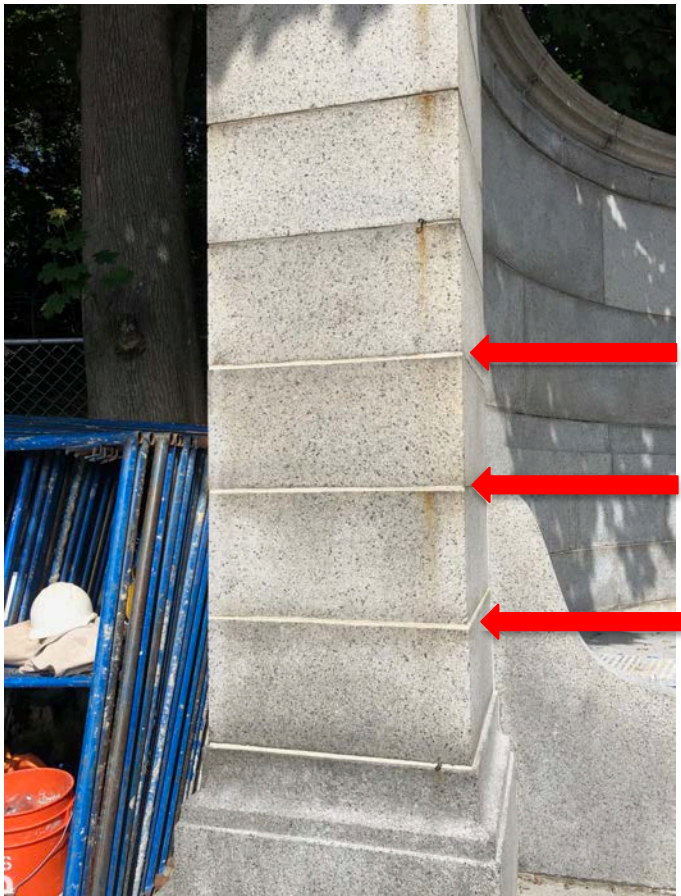
MM installed three mortar samples in the southwest pillar that were chosen for mock-up at the last site visit. One was a very good match and was approved by BCA (Figures 1,2).

Figure 1: Three mortar samples installed.

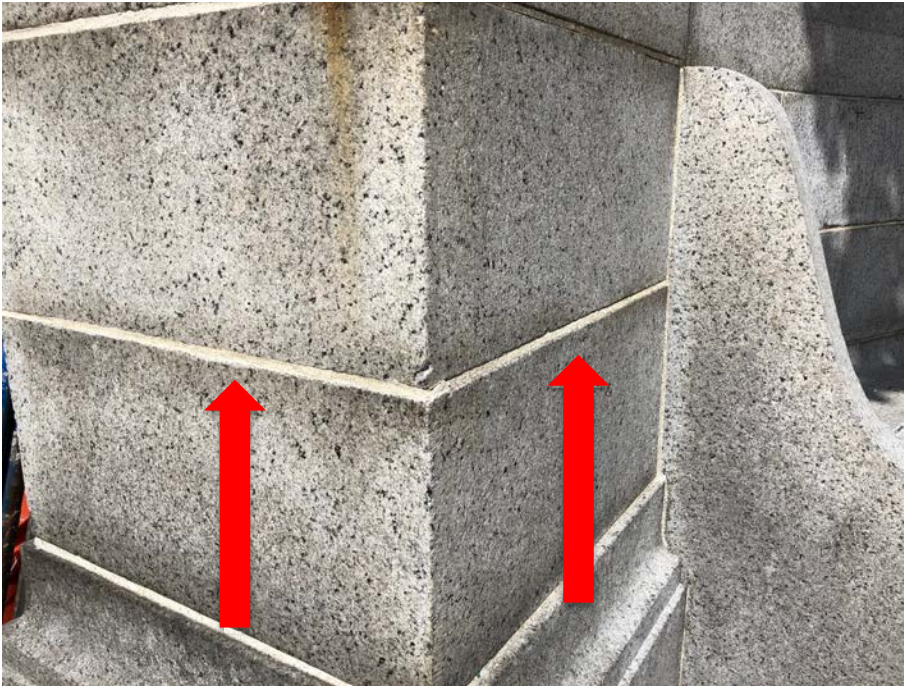
Figure 2: Mortar sample approved for use. Left, mortar mock-up, right original mortar.

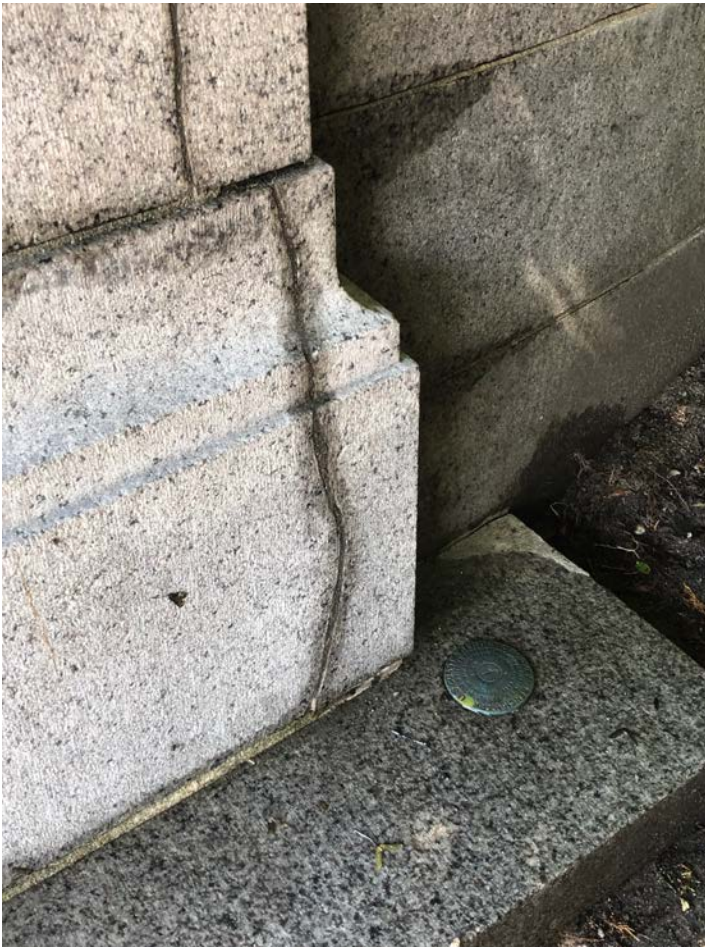
BCA review a crack repair on the northeast pillar. The installation of the repair was very good, however it had not yet dried out so could not be approved for final color (Figure 3).

Figure 3: Crack repair mock-up, not yet dried for approval.

- MM/Coastal to provide all submittals
- MM to send photographs of the crack and dutchman repairs once the areas have dried out
- MM to send photographs of cleaning, joint cutting, mortar installation as the work proceeds

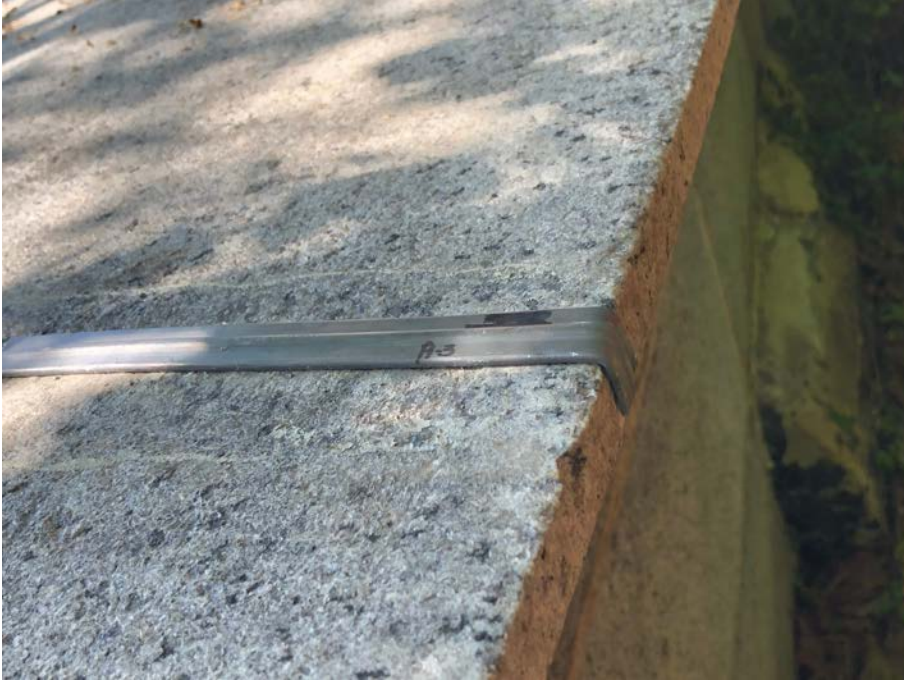
MM installed a WeatherCap lead "T" joint cover on the rear-facing capstone wall, north side. The installation was very good and approved (Figure 4).

Figure 4: Lead "T" joint cover mock-up, approved.

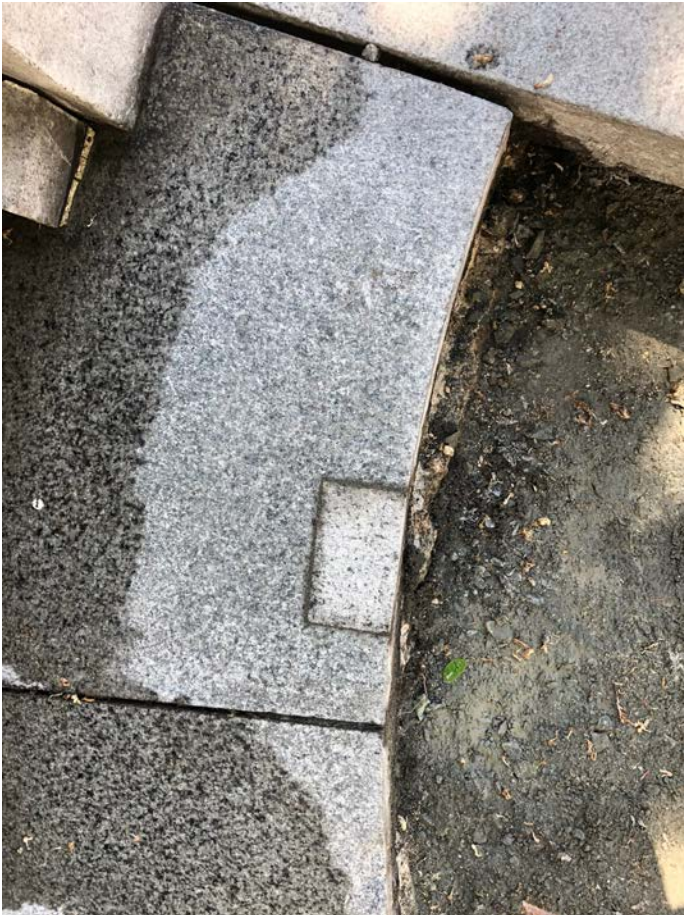
MM installed a small dutchman on the base stone at the front of the monument, northeast end, using salvaged stone from the rear of the monument. The installation was very good, however the joint around it had not yet dried, so its final appearance could not be assessed (Figure 5).

Figure 5: Dutchman installation, approval pending.

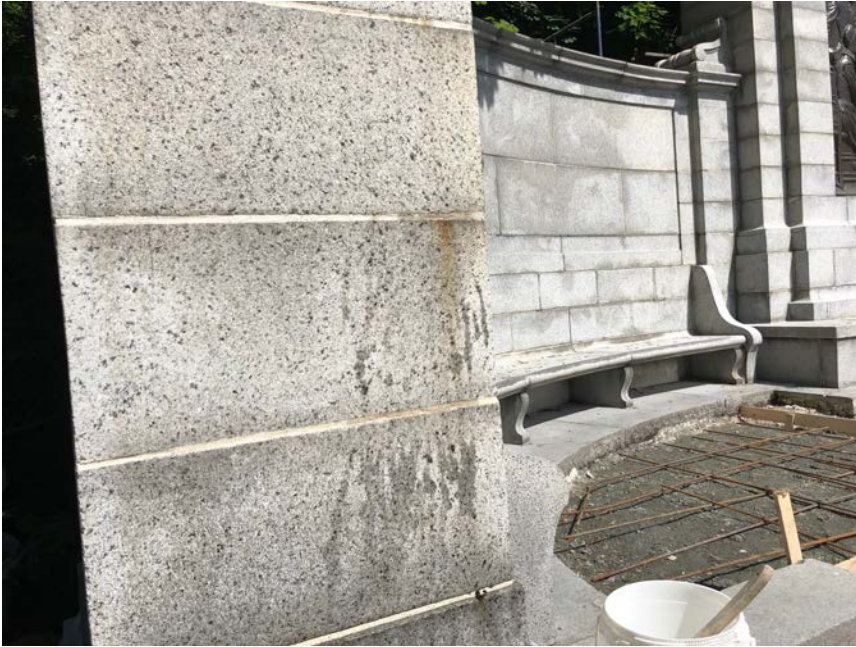
BCA brought additional cleaners to test for rust stain removal testing. These included Artisan Light Duty Rust Remover and Artisan Heavy Duty Rust Remover, both manufactured by Chemique, Inc. The Light Duty was ineffective, however the Heavy Duty produced very satisfactory results (Figures 6,7). There are very limited number of areas of with rust staining, primarily due to metal anchors that were used for decorative lighting. MM will spot clean these areas prior to an additional round of general cleaning.

Figure 6: Rust stain, prior to removal testing.

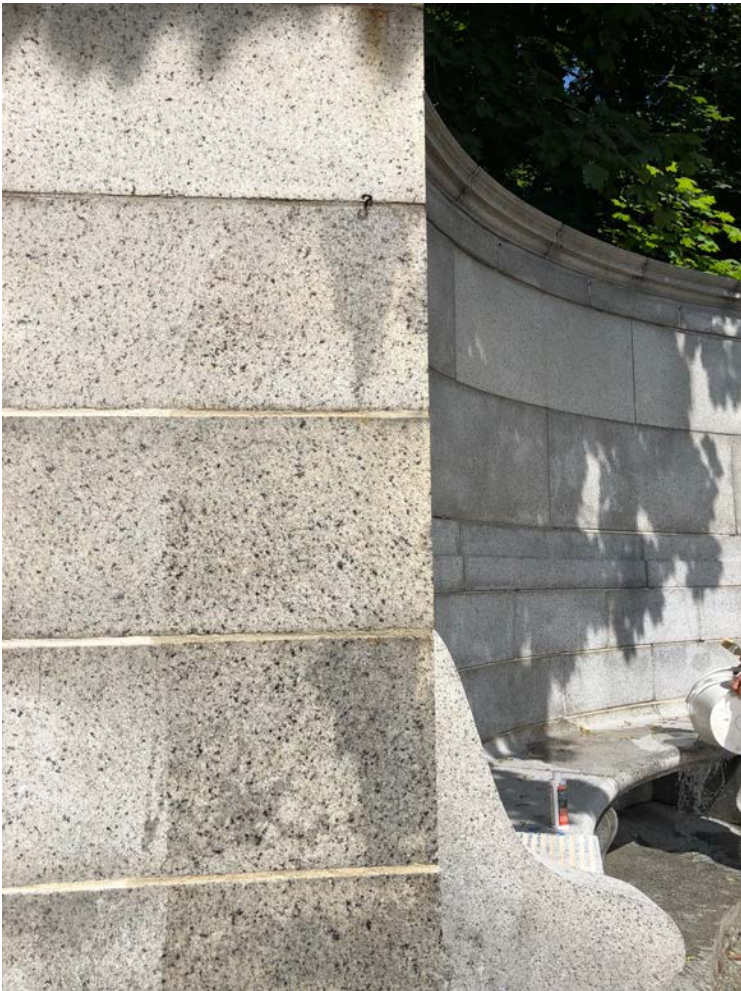
Figure 7: Rust stain removed with Artisan Heavy Duty Rust Remover.

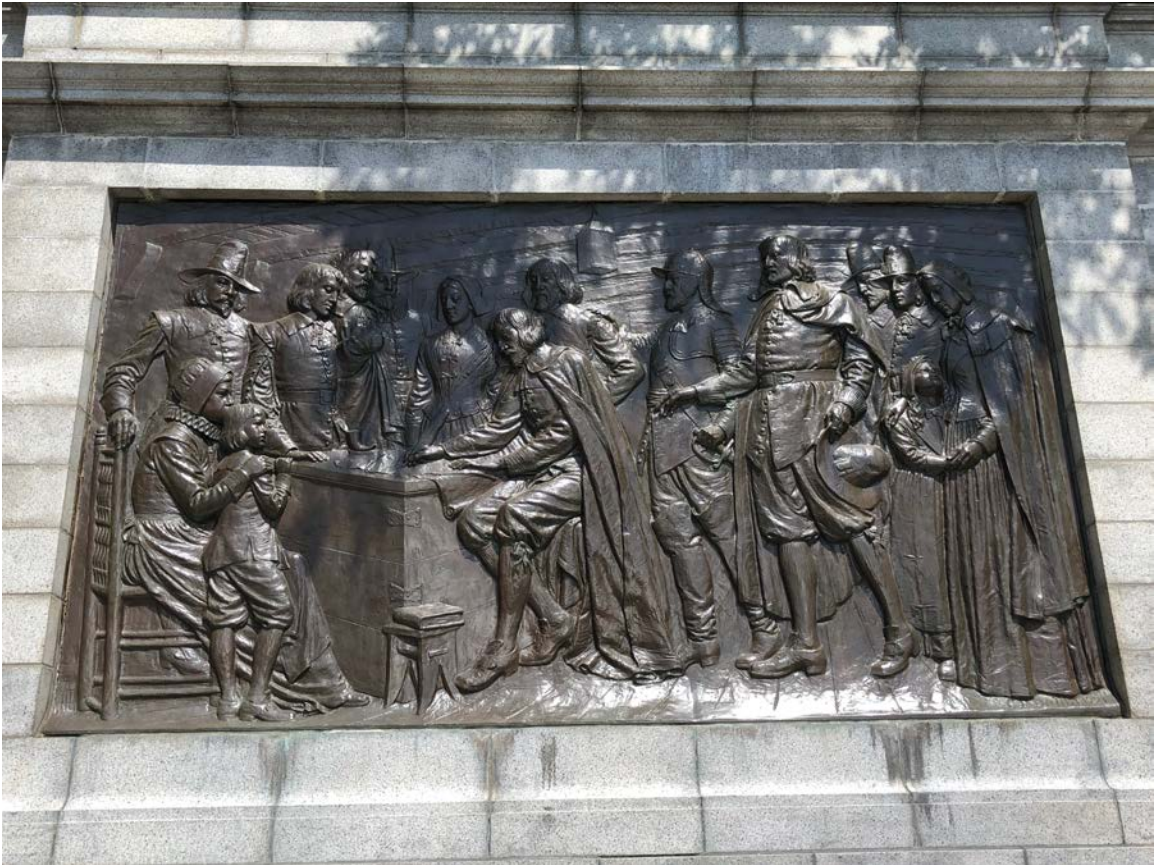
BCA noted that the bronze restoration was complete; the results are beautiful (Figure 8).

Figure 8: Bronze relief following conservation completion.
